Manhole Inspection Summary

Manhole # S47MM_005MH

Inspection ☐ Is Incomplete Rating: **3) Fair**

Location Address: **Sinclair**

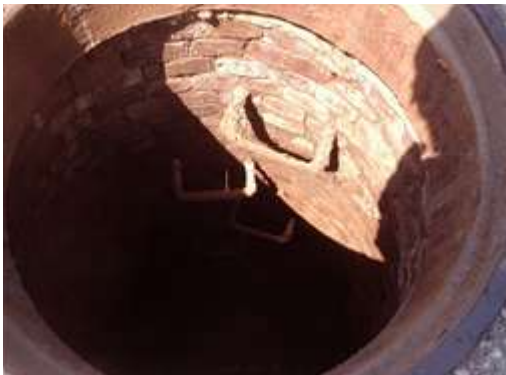
Defect 1

☒ **Leaks**

Frame leaks

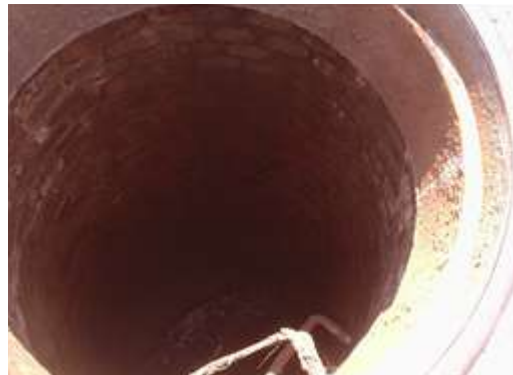
Defect 2

Infiltration: ☐ None ☒ **Joint** ☐ Cracks ☐ Mortar ☐ Roots ☐ Wall

Infiltration: ☐ None ☐ Joint ☐ Cracks ☐ Mortar ☐ Roots ☒ **Wall**

Infiltration

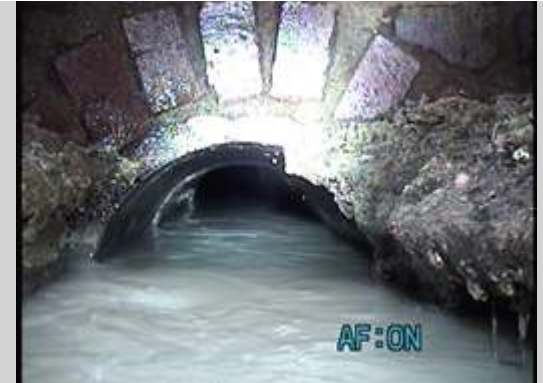
12 O'Clock Outflow

12 in. Circular Gravity Sewer
Pipe Out @ 12 O'Clock

Pipe Height: **12** (in.) Rod and Bar (Angled)
Pipe Material: **Clay** ☐ Pipe Lined
Invert Depth: **13.50** (ft.) Flow Characteristics: **Fast**
Deposits: ☒ None ☐ Mud ☐ Sludge ☐ Debris ☐ Grease
Silt Depth: (in.) Deposits Extent:
Infiltration: **None** Pipe Seal Cond: **Sound**
